PIGGING RESTORES INTAKE FLOW CAPACITY FROM QUAGGA MUSSEL FOULING IN GREAT LAKES

By: Rex Murphey, Montauk Services Inc.

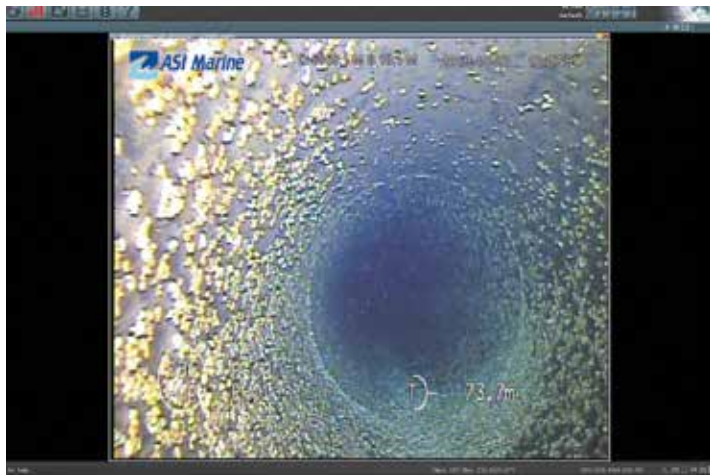
Figure 1. ROV pictures showing quagga mussel build up prior to pigging

In 2014 Remotely Operated Vehicle (ROV) inspections of the deep-water intakes extending from Island WTP into Lake Ontario documented quagga mussel infestation. Fouling was heaviest in deep water (250 ffw) at the mouth of the intakes, and the mussels adhering to the interior wall of the HDPE pipe created flow turbulence which diminished the volume of water delivered to the WTP facility, and also increased the pumping cost.

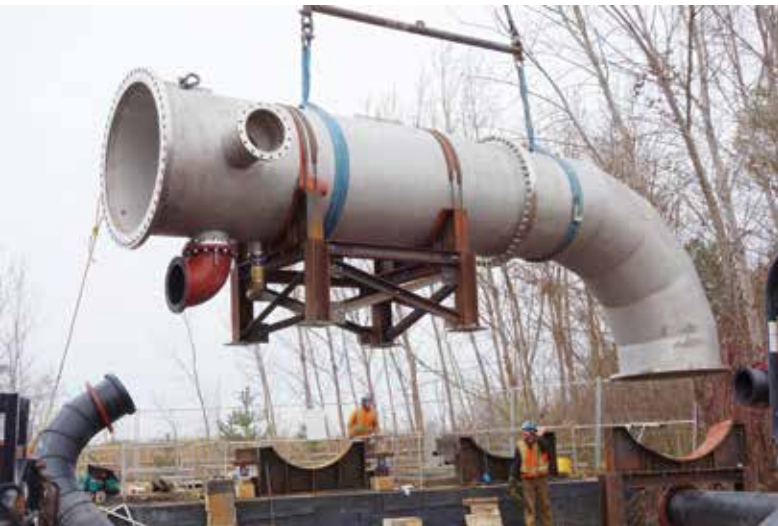
Figure 2.60-inch launcher being moved from one intake to another

For improved cleaning results, the launcher was designed and fabricated to accept oversized pigs at the upstream end. It had a reduced diameter on the downstream end, in order to fit the ID of pipe in the Intake Valve Chamber. Each of the intake lines had an independent connection for the pig launcher so that cooling water supply from two lines was kept in service while the third line was cleaned. The pig was propelled with water pumped from the shore side of Toronto Island passing beneath a temporary bridge installed by Galcon to maintain traffic along Lakeshore Avenue. The pumps were controlled to maintain uniform flow ranging between 18,000 and 20,000 gallons per minute. The three intake pipelines extended from approximately 16,500 LF to 17,300 LF between the Valve Chamber and intake mouth installed at 270 feet of water depth in Lake Ontario. Pig run times for each of the three intakes varied from 75 to 90 minutes. Each of the three intakes, (West, Center and East), were cleaned by three successive pig runs.

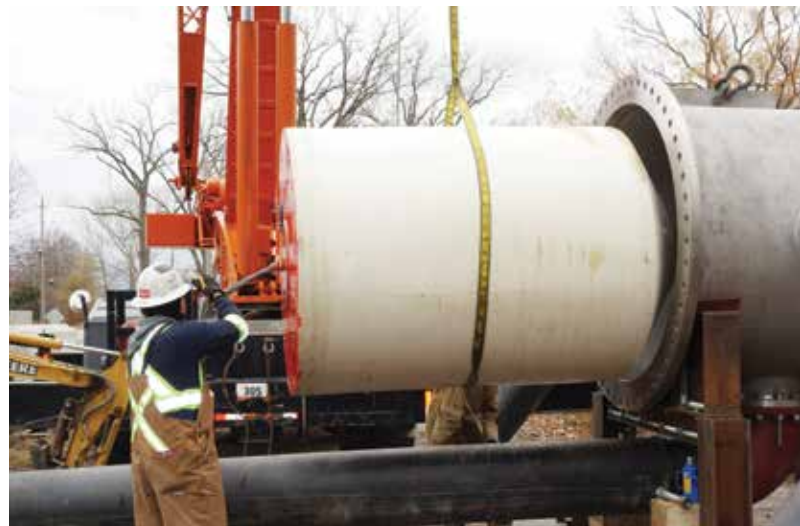
Figure 3.60-inch durafoam style pig being placed in launcher

Pigs clean through compression of the foam body as they pass along the pipe propelled forward from hydraulic pressure created by pumps discharging into the line behind the pig. Pigs used for cleaning are often larger in diameter than the ID of the pipe, much like pulling a very large sponge through a pipeline and scrubbing the wall surface as it moves along. The Toronto WTP lines were almost 61 inches ID, however the first pig deployed was a soft foam material and only 58-inch diameter. The intention was to create enough bypass flow to perform initial cleaning, but not have the pig adhere to the wall of the pipe or restrict its movement through the intake.

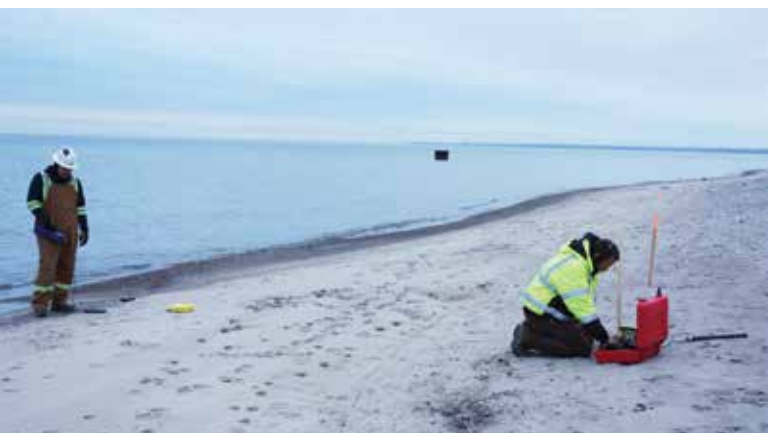
Figure 4. Each pig is tracked as it leaves the shoreline

With the surface support vessel and ROV stationed at the intake mouth, a pig would be loaded and launched. The pig was tracked as it left the launcher, and again as it crossed the beach into Lake Ontario. If any problem developed during pig transit, gauges and data-loggers would indicate a pressure surge, providing data on the estimated location of the pig. Pigging time was recorded and documented for each run. Just before the pig discharged, a slight change in pressure accompanied the opening of the pipeline.

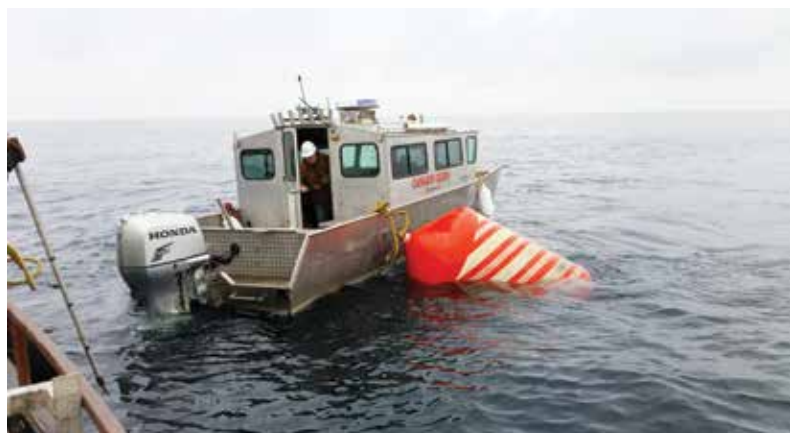
Figure 5. 60-inch brush pig being readied for tow back to shore

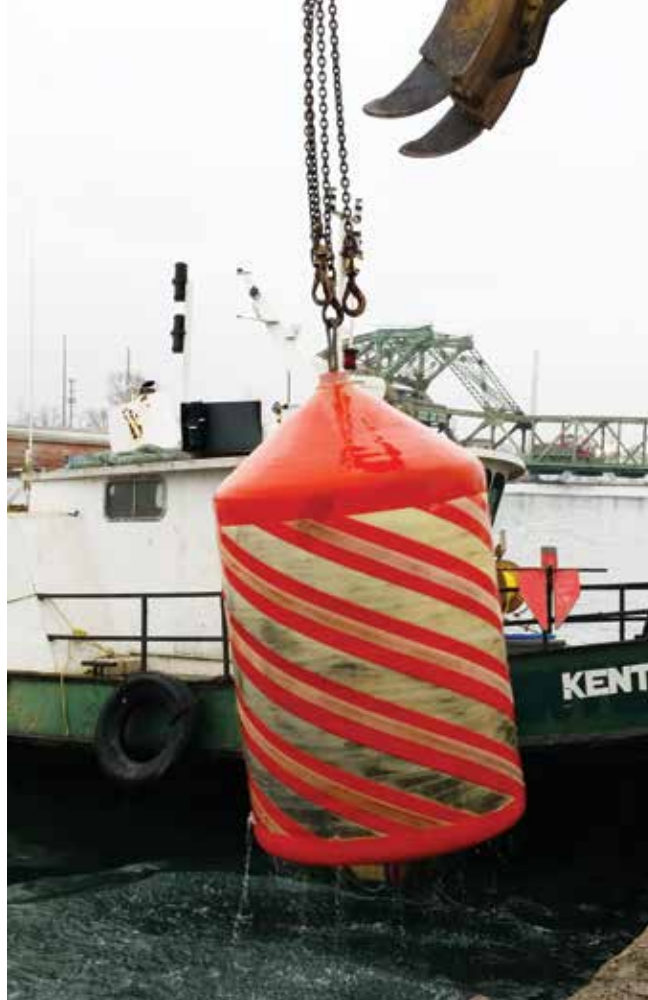
Figure 6.60-inch brush pig after being towed to shore
